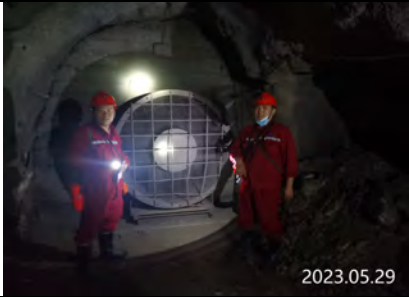
29	GX-B1341/21-9-23166	6.14	综合判定：合格。

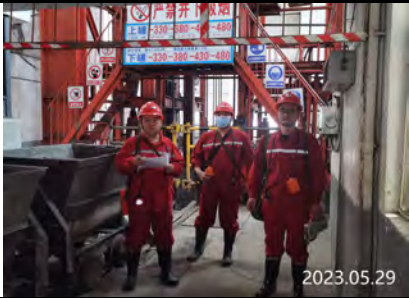
<p>2023.05.29</p>
30	GX-B1343/21-9-23024	6.14	<ol style="list-style-type: none"> <li>1. 矿井总风量：5014.8m<sup>3</sup>/min;</li> <li>2. 主通风机风量：5058.6m<sup>3</sup>/min;</li> <li>3. 矿井有效风量：3903.4m<sup>3</sup>/min;</li> <li>4. 矿井有效风量率：77.2%;</li> <li>5. 机站风量：5058.6m<sup>3</sup>/min;</li> <li>6. 机站风压：1450Pa;</li> <li>7. 矿井通风阻力：1294.9Pa。</li> </ol>

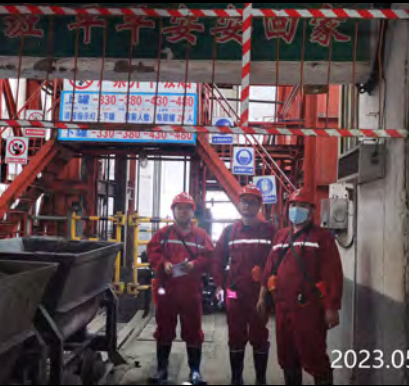
<p>2023.05.29</p>
31	GX-B1347/21-9-23017	6.14	<ol style="list-style-type: none"> <li>1. 风量（风速）合格率：100%，大于65%，合格；</li> <li>2. 风质合格率：100%，大于90%，合格；</li> <li>3. 作业环境空气质量合格率：100%，大于60%，合格；</li> <li>4. 矿井有效风量率77.2%，大于60%，合格；</li> <li>5. 风机全压效率为72.2%，大于70%，合格；</li> <li>6. 风量供需比1.37，符合<math>1.32 \leq \beta \leq 1.67</math>要求，合格；</li> <li>7. 综合指标90.7%，大于72%，合格。</li> </ol>
