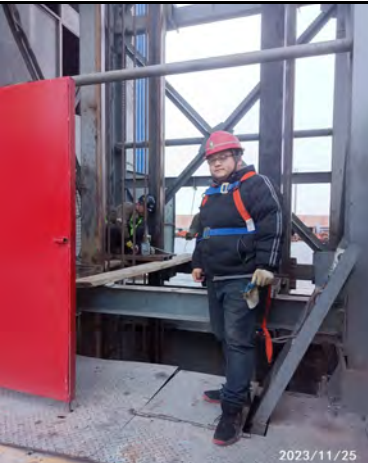
23	GX-B1598/21-2-23183	2023. 12. 4	实测钢丝绳有效截面积 损失百分比最大为 1.83%，小于5%为正常。

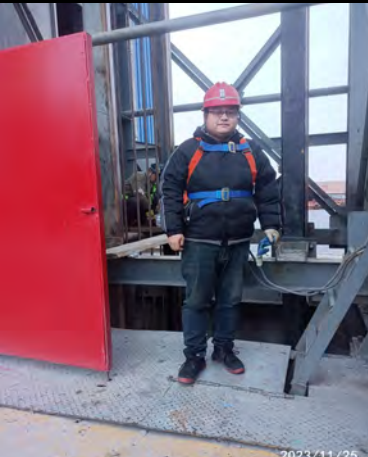
24	GX-B1598/21-2-23184	2023. 12. 4	实测钢丝绳有效截面积 损失百分比最大为 1.68%，小于5%为正常。

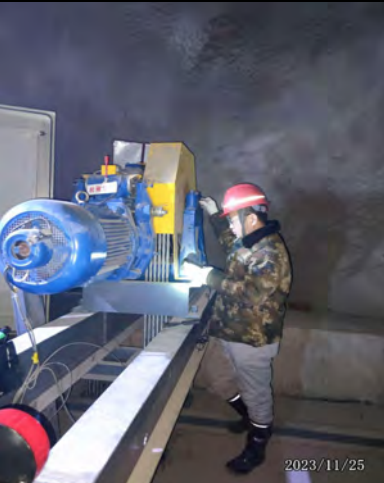
89	GX-B1310/21-2- 23387	2023. 12. 4	符合标准要求。

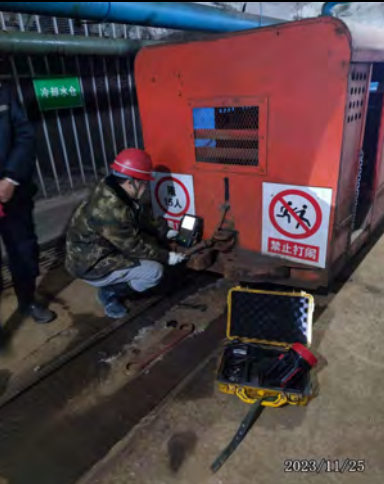
<p>2023/11/25</p>	
90	GX-B1310/21-2- 23388	2023. 12. 4	符合标准要求。

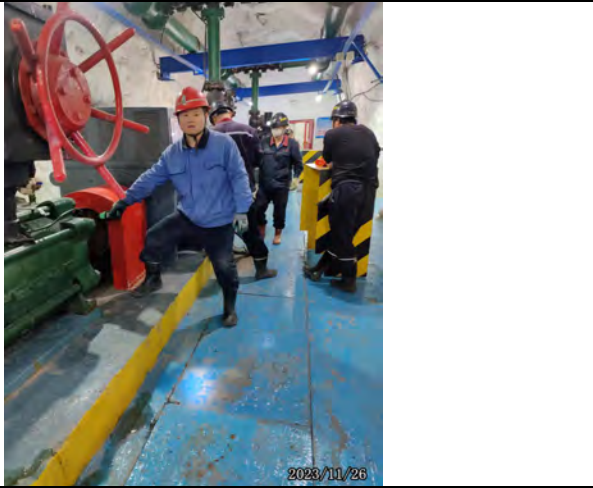
95	GX-B1500/21-2-23136	2023. 12. 4	综合判定：合格。

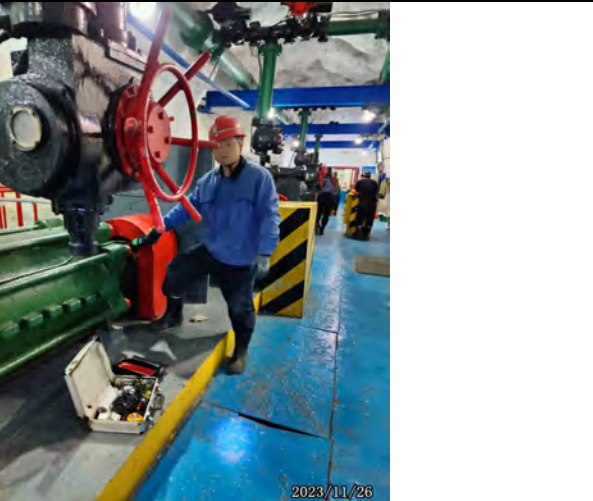
96	GX-B1500/21-2-23137	2023. 12. 4	综合判定：合格。
